Client:
THE CHURCHES
CONSERVATION TRUST

Project:
THE CHAMBER AT ST JOHNS

Title:
EXISTING ROOF STRUCTURE
CONDITION

Drawing No:
1059 033

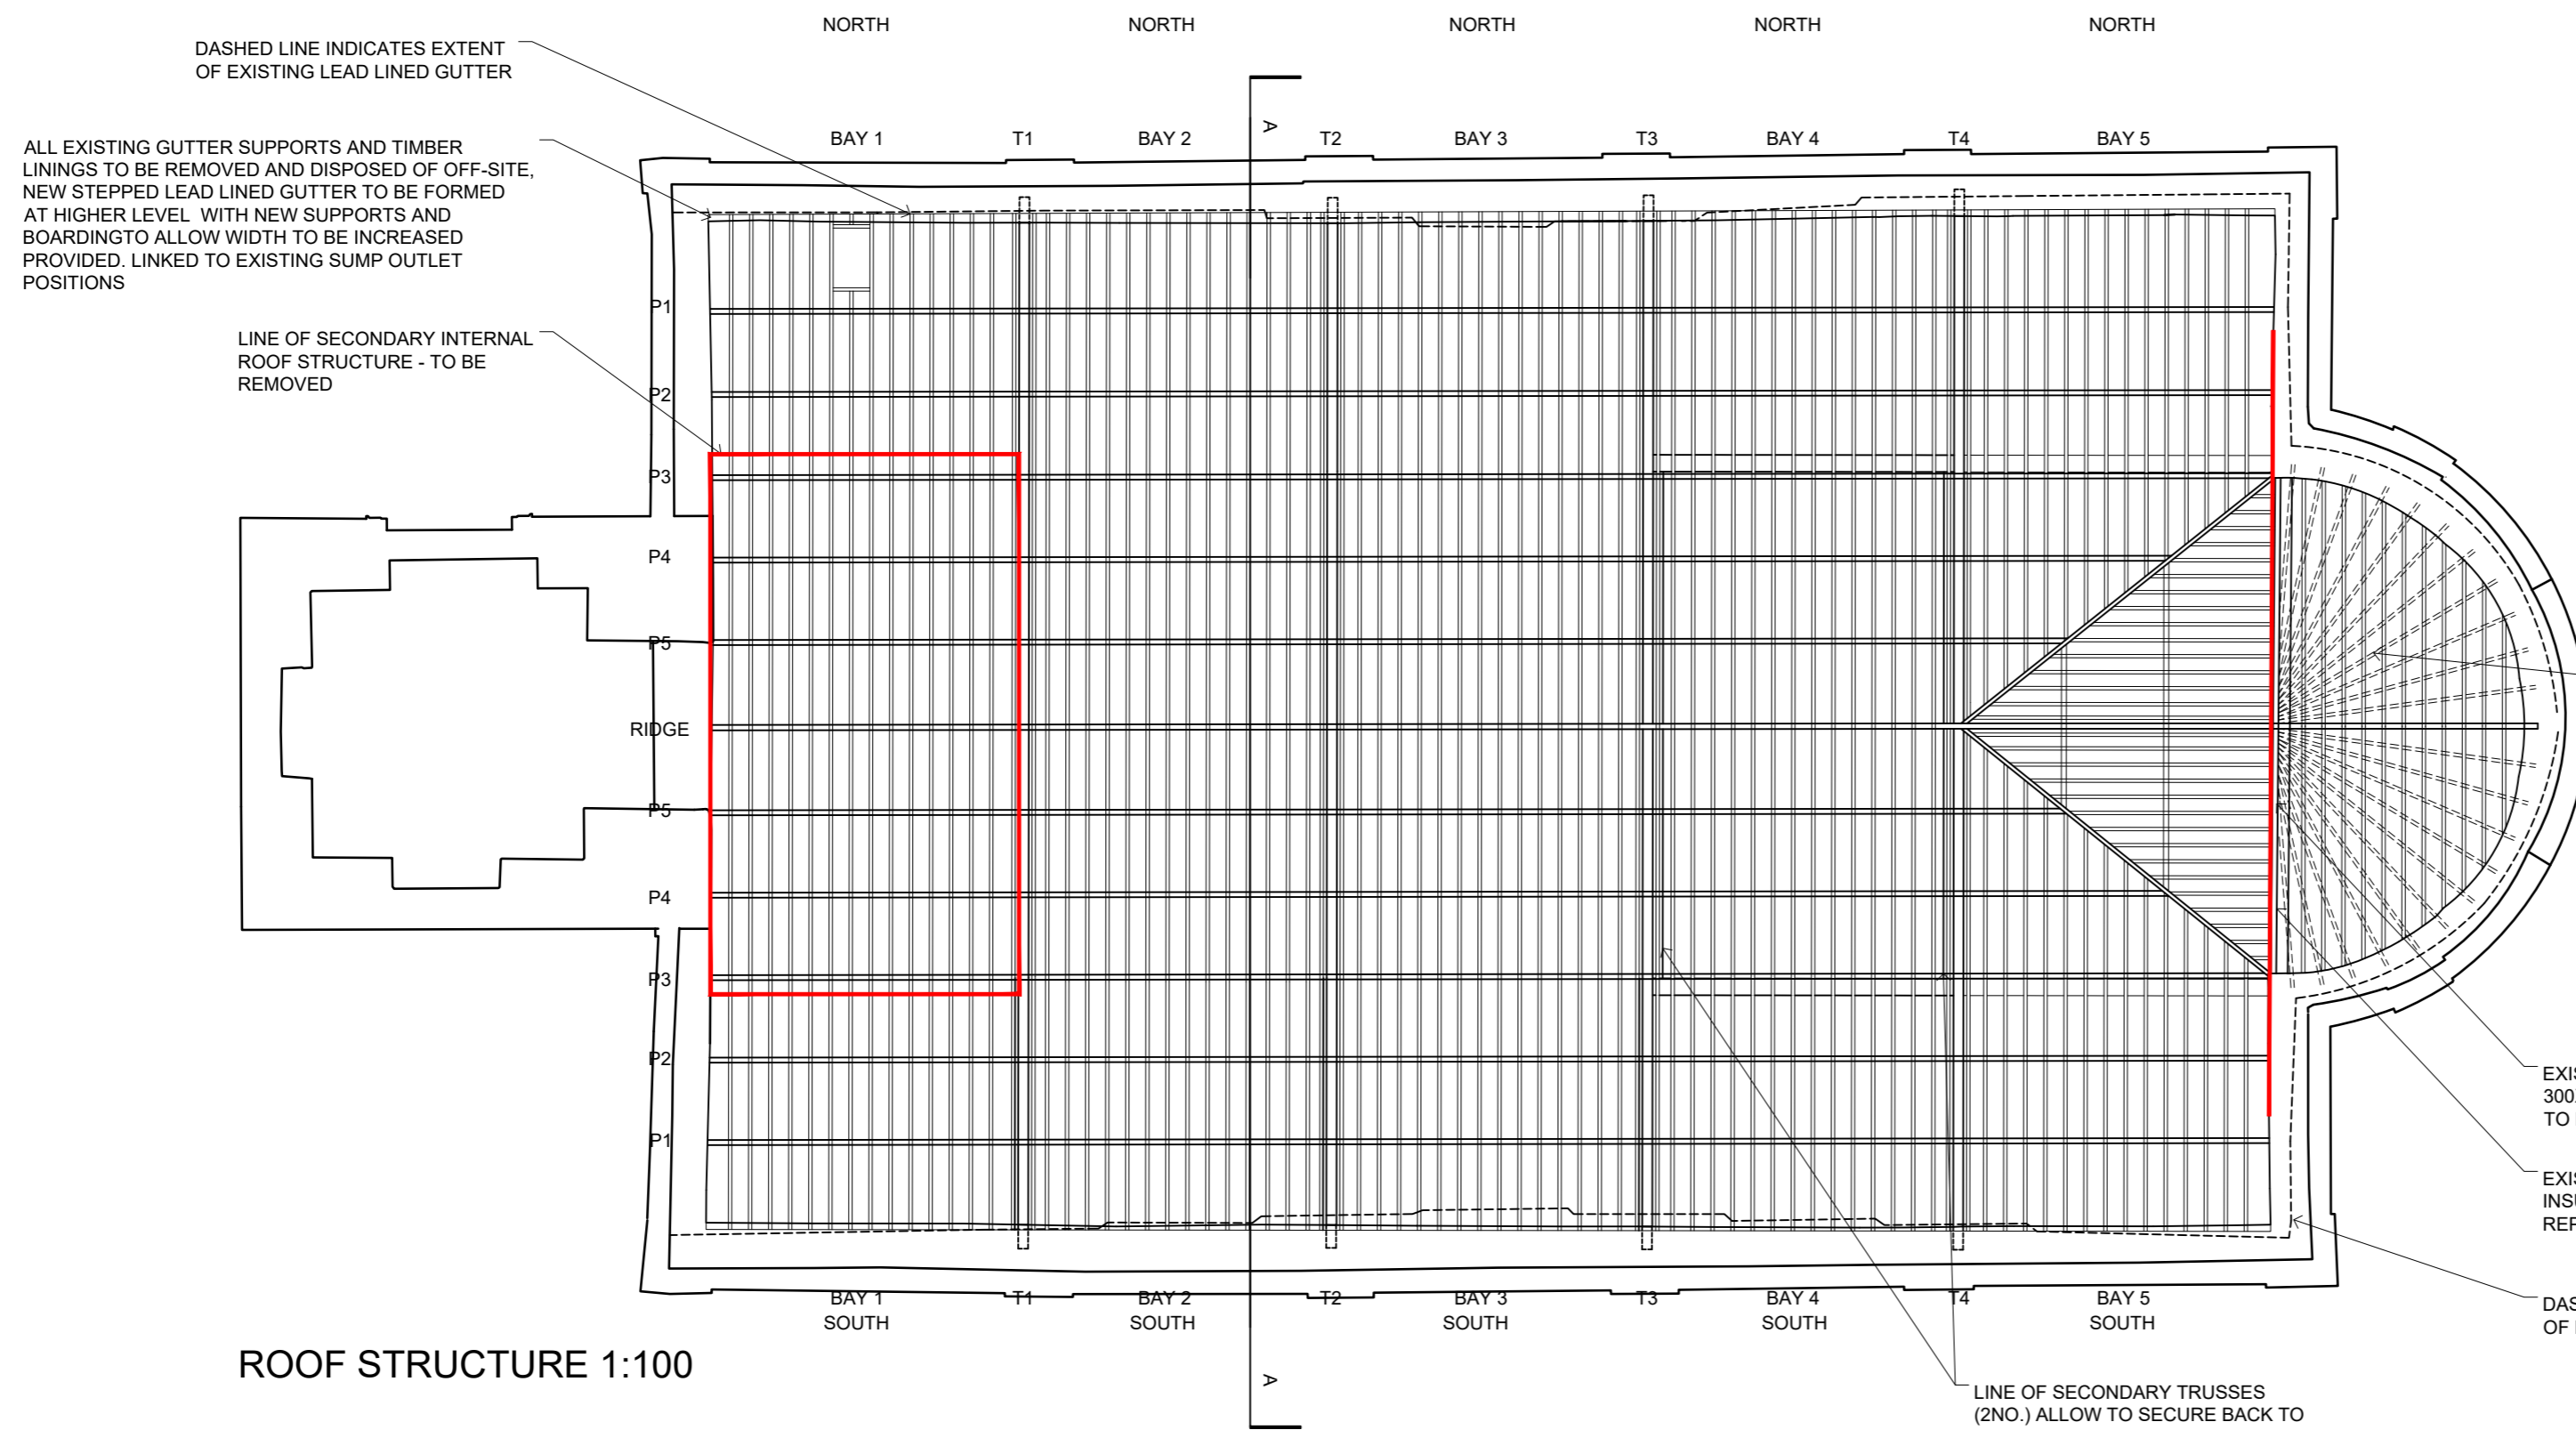
ROOF STRUCTURE 1:100

EXISTING STRUCTURE (FROM PHOTOGRAPHS) APPEARS TO CONSIST OF AN ARRAY OF TIMBER ROOF JOISTS SUPPORTED FROM THE MAIN TIMBER BEAM THAT RUNS N/S ACROSS THE APSE. HOWEVER THE ROOF FORM SUGGESTS A SECONDARY LAYER OF STRUCTURE TO FORM THE TWO ROOF SLOPES VISIBLE EXTERNALLY. ALLOW TO FULLY REMOVE LEAD WORK AND UPPER LAYER OF STRUCTURE. ALLOW 8NO. SPLICE REPAIRS TO ORIGINAL ROOF JOISTS. RE-SECURE ALL CONNECTIONS WITH S/S SCREWS AND INCLUDE 10NO. ADDITIONAL NOGGINS. FORM NEW ROOF STRUCTURE IN TREATED TIMBER TO ADEQUATE FALLS ABOVE WITH NEW SARKING. NEW LEAD ROOF WITH BATTEN ROLLS AND VENTILATED CONSTRUCTION OVER

EXISTING METAL TIE BEAM OF INSUFFICIENT SECTION. ALLOW TO REPLACE WITH NEW

DASHED LINE INDICATES EXTENT OF EXISTING LEAD LINED GUTTER

- TIMBER REPAIR ALLOWANCES TO MAIN ROOF**
- APPROX 150 EXISTING RAFTERS: ALLOW FOR 75 NEW SIDE ALONG RAFTER REPAIRS FROM EAVES SUPPORT TO FIRST PURLIN
 - RAFTER WALL PLATE: ALLOW FOR FULL REPLACEMENT ALONG BOTH NORTH AND SOUTH WALES RESIN BOLTED DOWN INTO WALL HEAD. ALLOW FOR RECONSTRUCTION OF SAY 200MM DEPTH OF MASONRY BENEATH WITH LIME MORTAR

- APPROX 50 PURLINS: ALLOW FOR 10NO. SPLICE REPAIRS TO ENDS AND 10NO. NEW PURLIN SECTIONS BETWEEN TRUSS SUPPORTS
 - 4NO. TRUSSES: ALLOW FOR REMOVAL OF EXISTING FERROUS METAL BRACKETS AND SECONDARY STEEL STRENGTHENING TO ALL TRUSSES. ALLOW FOR 4NO. SPLICE REPAIRS TO BEARING AT SOUTH END OF TRUSSES AND REPLACEMENT OF 5NO. SECTIONS OF EXISTING TIMBER WITH NEW KILN DRIED OAK UP TO 200X300MM SECTION AND UP TO 3M IN LENGTH.

EXISTING TIMBER BEAM APPROX 300X300MM. ALLOW FOR SPLICE REPAIRS TO BOTH ENDS WITH NEW HARDWOOD
