THE CHURCHES
CONSERVATION TRUST

ST MARGARET'S CHURCH

Hales, N

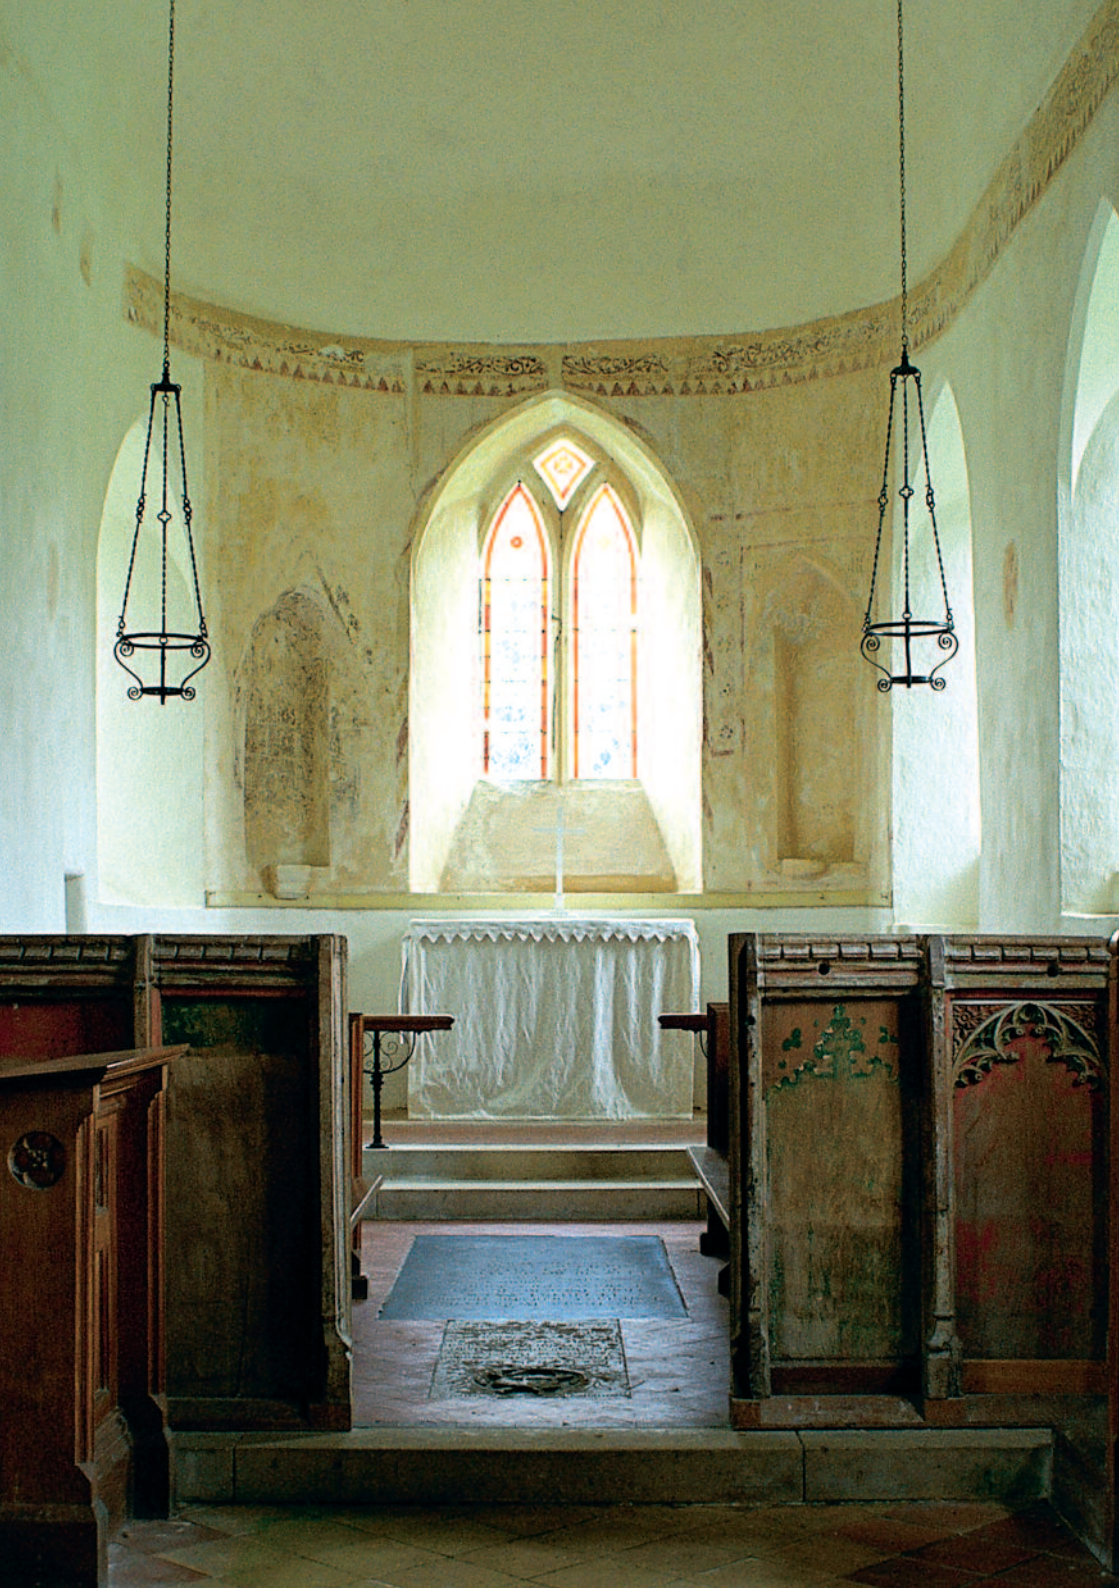
Left: Interior looking east (Borris Baggs)

The interior of the chancel now has a plaster vault and the chancel arch is a 14th-century replacement of the original. Below it are the remains of the late mediaeval screen.

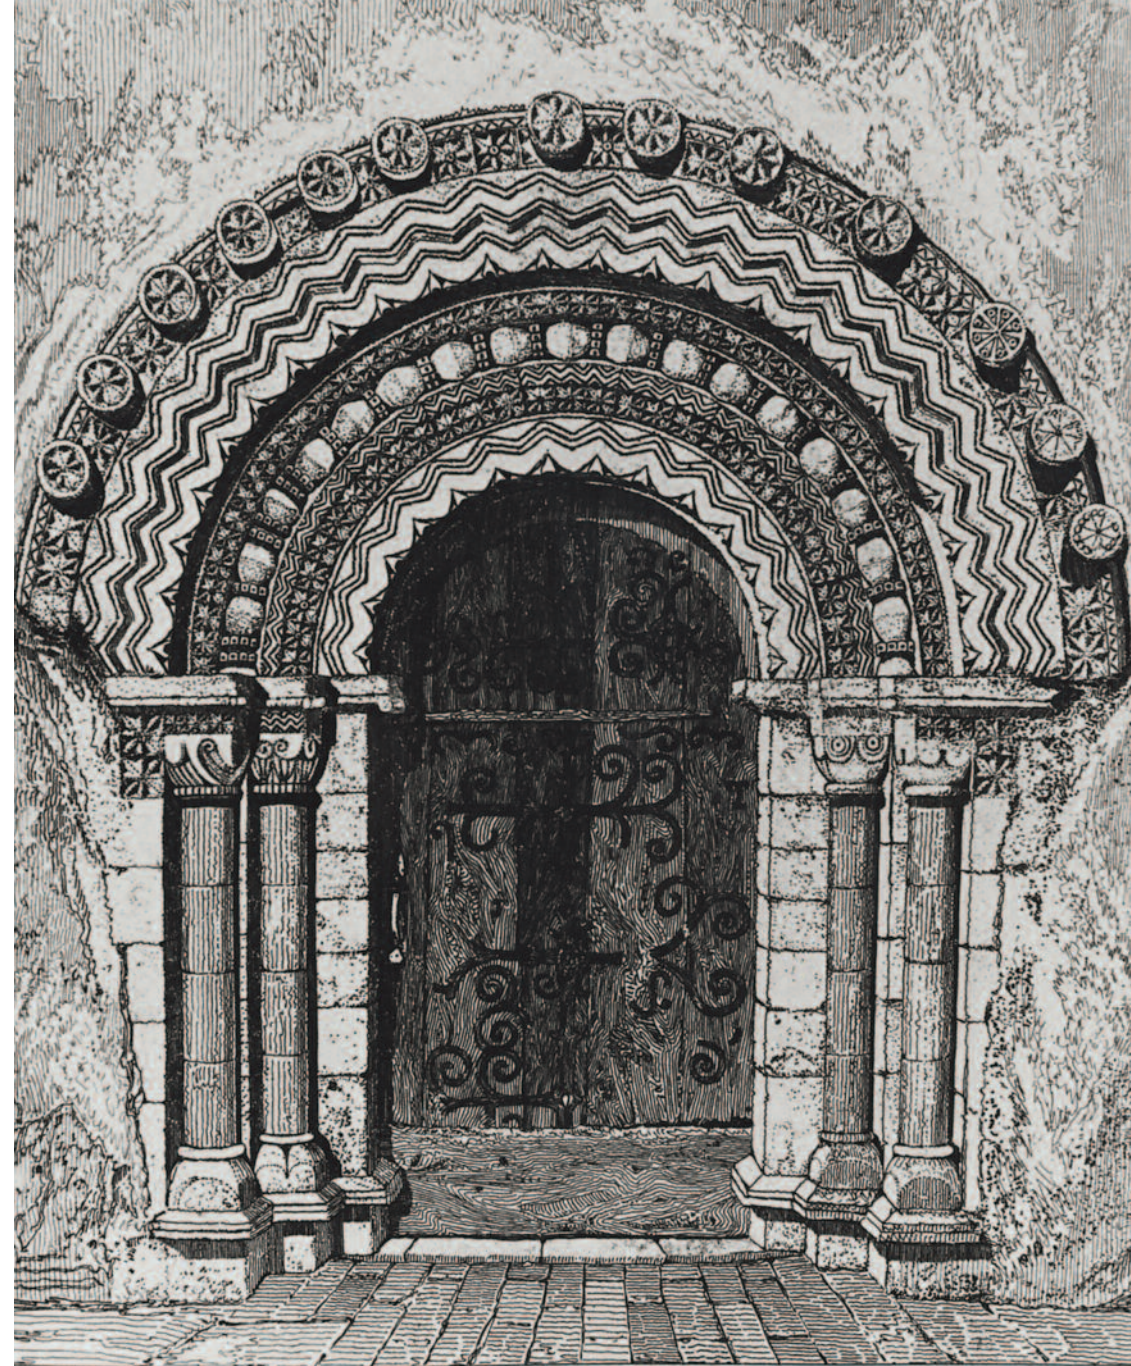
Right: Hales, St. Margaret, by John Sell Cotman (1838); nave north doorway. The arch has five principal bands of ornamentation consisting of chevron, chip carving, barrel or double cone and roundels. The original ironwork on the door is now lost. Reproduced by permission of The School of World Art Studies and Museology, University of East Anglia.

NORTH DOORWAY HALES CHURCH.
 TO HIS HONOURABLE LORDS THE BISHOP OF NORWICH AND THE CHURCH OF HALES.
 THIS PLATE OF ONE OF THE FINEST
 ARCHES IN EXISTANCE BUILT
 BY THAT NATION WITH WHICH HIS
 ANCESTORS CAME INTO NORFOLK.
 IS MOST RESPECTFULLY INSCRIBED
 BY JOHN SELL COTMAN.

The north door of the church had very elaborate Romanesque ironwork which was recorded by the artist John Sell Cotman. Unfortunately the fine engraving is the only record that remains of this bold decoration.

The nave doorways are rightly considered to be among the best in East Anglia. The north doorway, which is the principal entrance, has two orders supported on free-standing shafts (see page 3). There are two orders decorated with chevron ornament, the well-known zigzag decoration occurring in Anglo-Norman major buildings from around 1100. There is another arch enriched with a pattern of chip carving while the middle order has the distinctive motif of barrel shapes or double cones which occur for the first time in the region on the west face of the north transept of Norwich Cathedral. This motif was commonly used by the Norfolk school of Romanesque architectural sculpture centred around Norwich Cathedral. The flanking shafts have small volute capitals and in turn are flanked by panels of chip carving, a decoration known in Normandy before the Conquest. Finally there is a hood-mould studded with richly-carved petalled roundels.

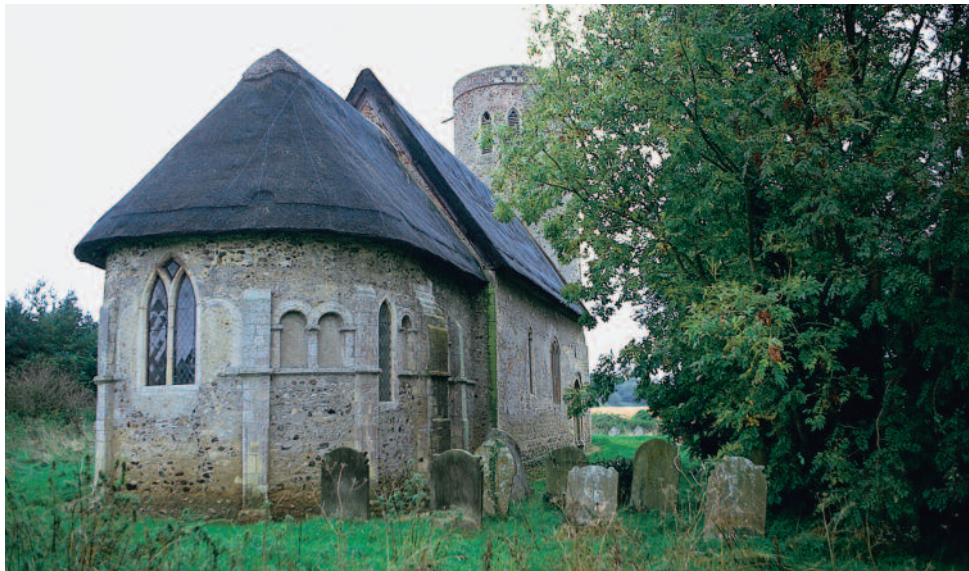
Left: The apse (Boris Baggs)

flanked with little nook shafts. In itself this reaches a rare degree of elaboration, but more unusual is the surviving apsidal chancel. Its curving plan is supported by buttresses and decorated with blind arcading and all the limestone dressings have roll mouldings. There is a bold string-course decorated with drilled conical bosses at the level of the sills of the blind arches. These have roll mouldings and chamfered impost. Some of the arches are further decorated with half roundels. All this, and in particular the sculpture on the doorways, suggests a date around 1140 for the nave and chancel.

The buttresses, in particular the large pair at the level where the apse begins to curve, suggest that the chancel was originally vaulted with masonry. It probably had a barrel vault with

a semi-dome in the apse penetrated by the windows. The patched masonry along the top of the chancel wall is also evidence of the former vault which was part and parcel with the masonry of the upper parts of the chancel walls. When the vault was taken down, or when it fell down, the tops of the chancel walls had to come down too and were rebuilt to a slightly higher level than originally, with markedly inferior workmanship.

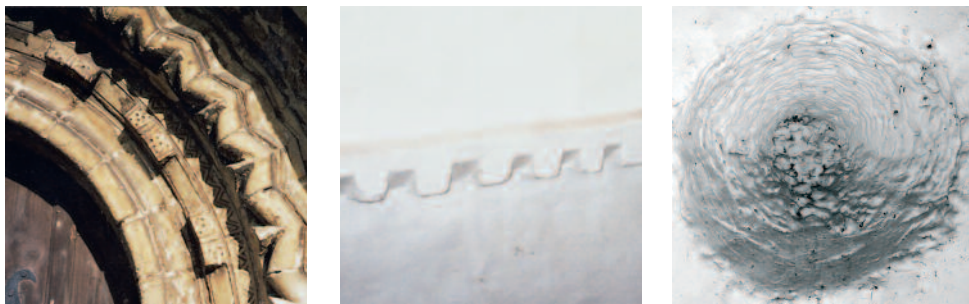
Left: Detail of southern carved doorway showing 'keeled billet' moulding (Kate Weaver)

The dentil imposts to the tower arch (Kate Weaver)

The basketwork imprint on one of the circular double-splayed windows (Sue White)

The south doorway is treated in a different way but just as richly and using another distinctive motif characteristic of the Norfolk School. This can be seen on the second innermost arch where there is a single string of billet moulding which is a band of short raised roll moulding sections with blank spaces in between. In this case the roll mouldings are in fact of a 'keel' shape, almost triangular in section (see page 8). Keel mouldings were quite commonly used in Romanesque sculpture of the middle years of the 12th century. Characteristic of the Norfolk school is the use of keel billet on the one hand and on the other that the sections are decorated with drilled holes. Fragments of this type of ornament have been found at Norwich Cathedral and they were probably part of the Romanesque cloister which was under construction from about 1130 to 1140. It was demolished and rebuilt as a result of the damage inflicted on it by rioting Norwich citizens in 1272.

The ground floor of the tower, which is entered through the doorways beneath the gallery, has the most interesting of the windows. There are two partly blocked circular windows which have embrasures or splays to the inside and outside faces of the wall. The internal splays are visible and reveal the clear imprints of basketwork showing that the windows were built by using basketwork shuttering threaded through a central board and left *in situ*. This technique can be seen in many early churches in the region and although often regarded as an indication of Anglo-Saxon date, it is no more than an indication of indigenous workmanship – a practical response in an area which has no local source of good quality freestone and an abundance of low-lying ground ideal for the growing of osier. In this case the windows cannot be earlier than the middle years of the 12th century.

extension to the liturgical space. A large archway, partly blocked and obscured by the west gallery, is visible and the arch springs from crudely carved dentil imposts. The round double-splayed windows, the rubble dressed openings and the crude decoration are in distinct contrast with the sophistication of the nave and chancel. The wealth available for the construction of the nave and chancel had disappeared by the time it was considered necessary to build a tower. Therefore it was constructed with virtually no expensive imported materials and using local craftsmen to build the typical Norfolk round tower.

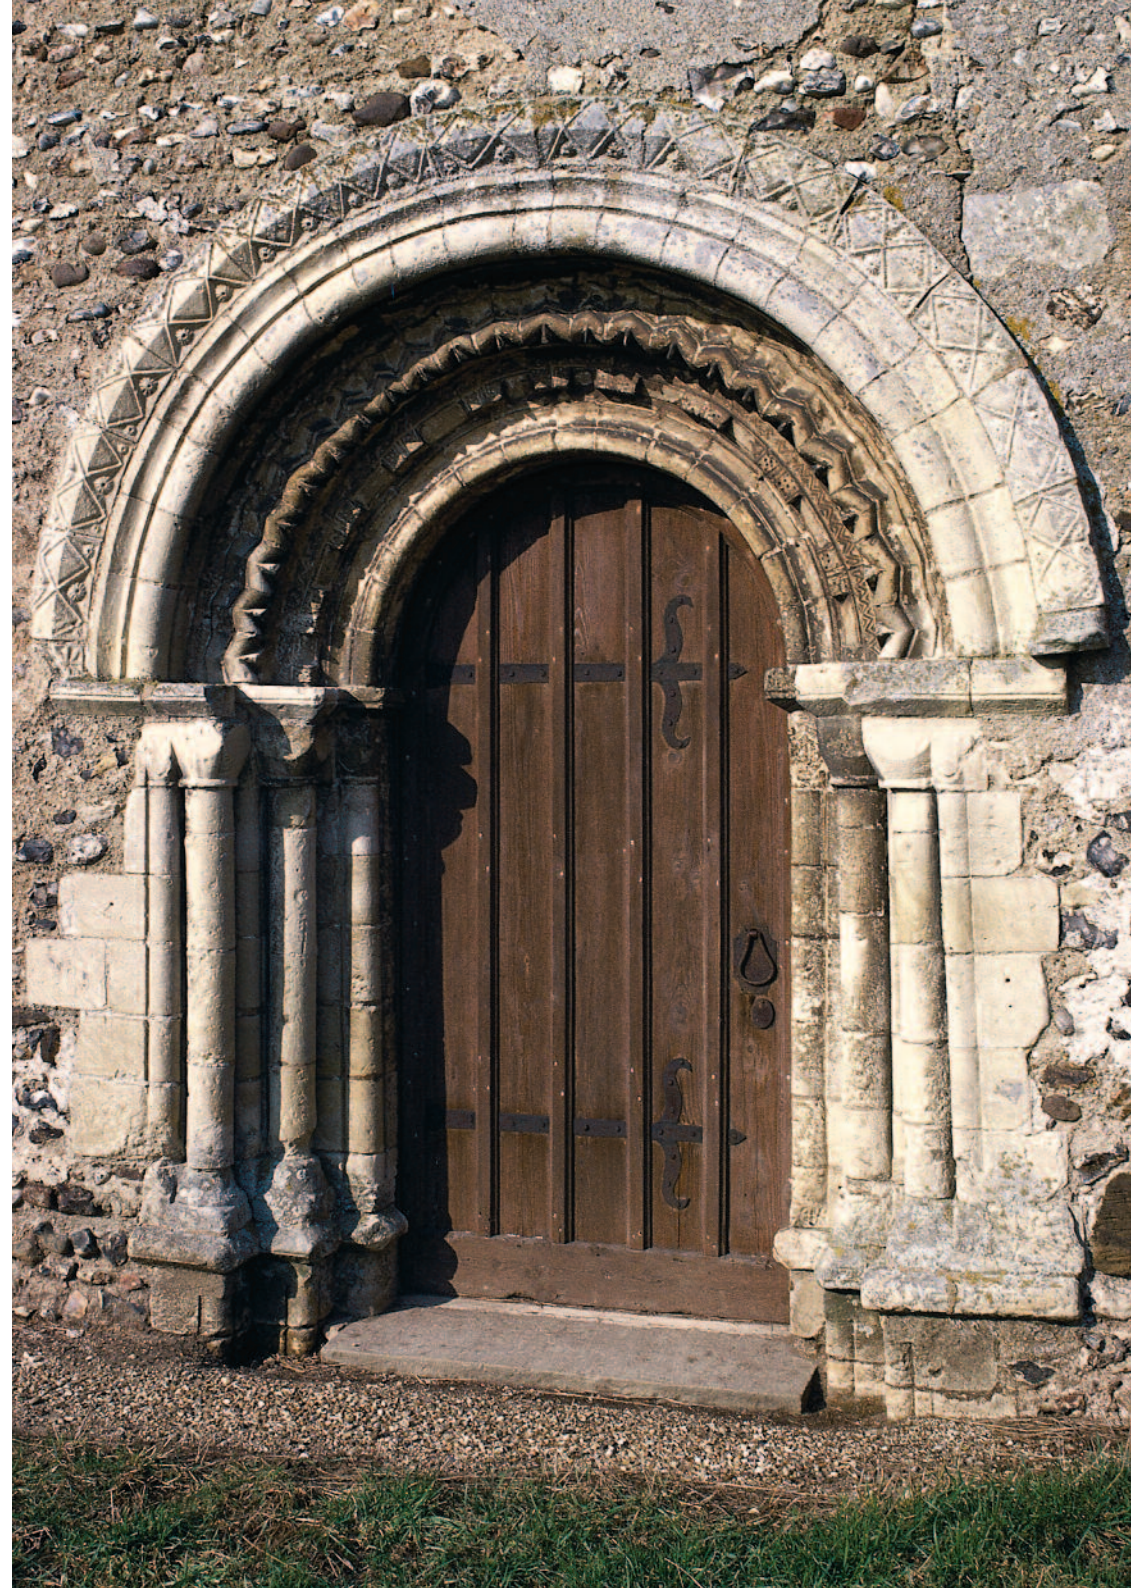
Right: The south door (Christopher Dalton)

Each doorway, constructed with fine limestone imported from Normandy, has three arches carved with Romanesque motifs supported on colonettes. The four corners of the nave are decorated with roll mouldings and the one surviving original window on the south side is
