ALL SAINTS' CHURCH

Icklingham, Suffolk

by Roy Tricker (Field Officer with The Churches Conservation Trust 1991–2002, church enthusiast, historian and lay canon)

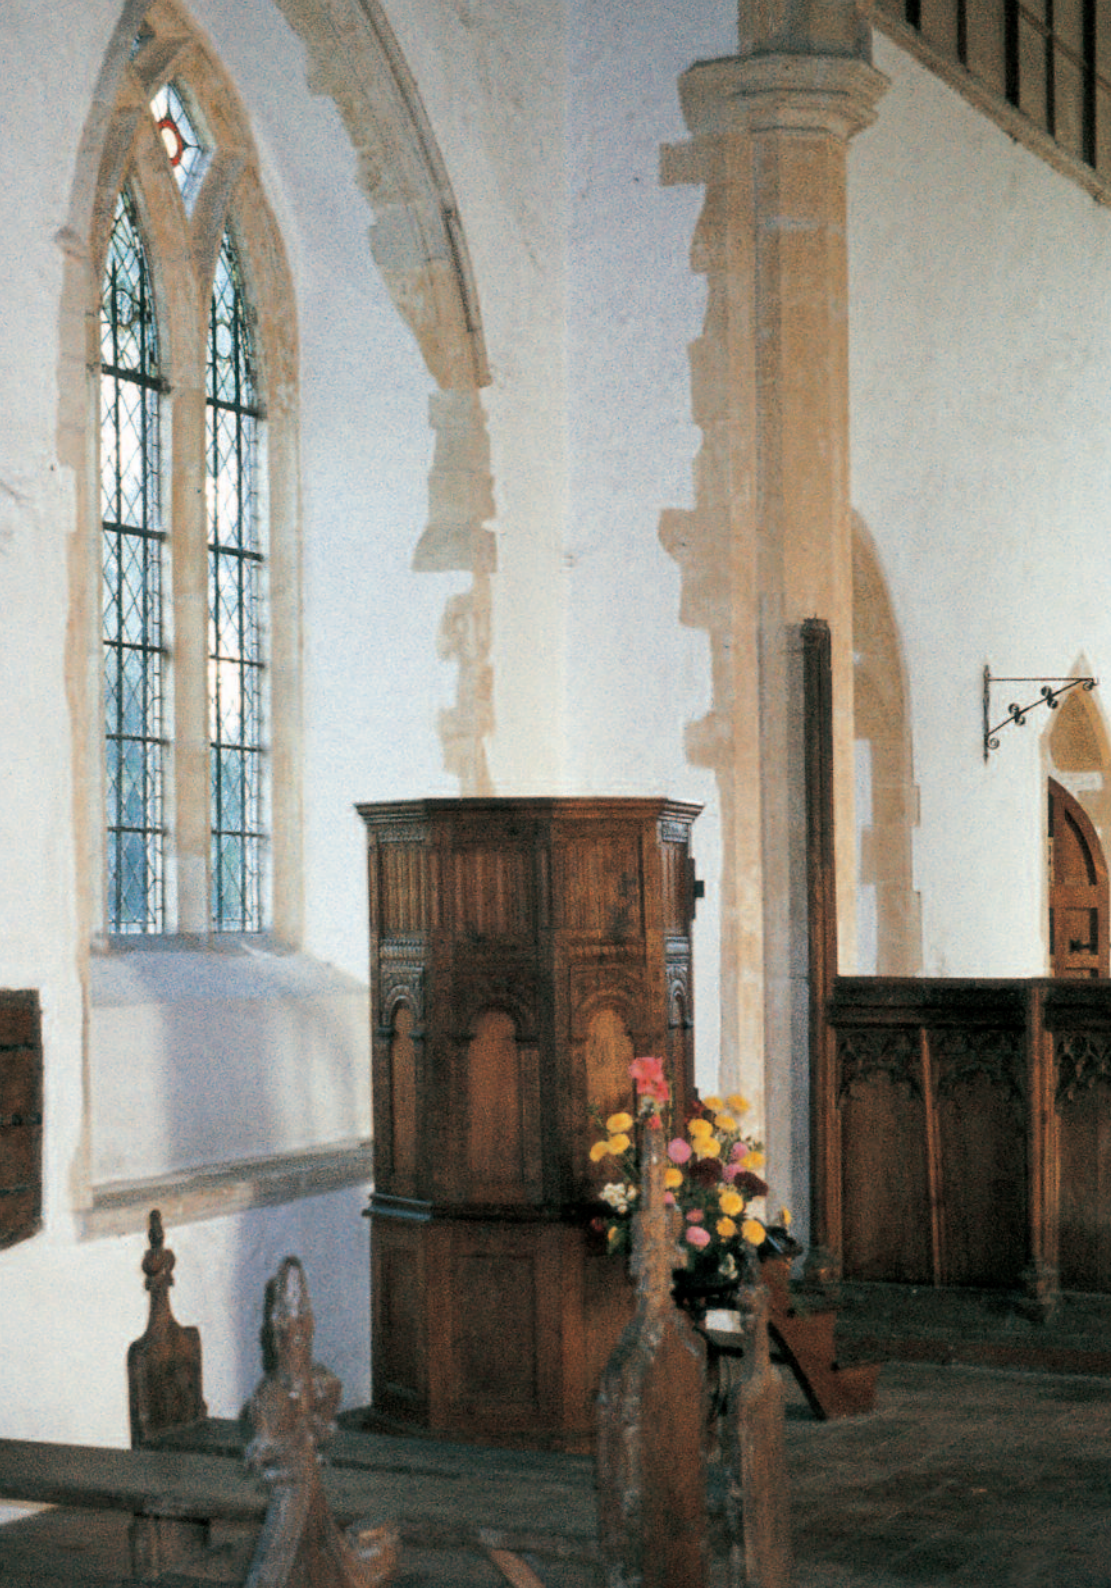
Left: The 17th-century pulpit and 15th-century screen base and benches (Christopher Dalton)

The 17th-century **pulpit**, with characteristic carving of the period, was once part of a three-decker arrangement. What was almost certainly its **reading desk**, looking like a large box pew, is now in the south aisle, near the entrance. The pulpit base has been renovated, but the

Most of the **benches** in the nave and aisle are 15th century and show signs of wear caused by over 500 years of use. They are backless, their ends having mostly small terminations, although a few have larger poppyhead ends and one has flat-topped ends. Indeed they are such a mixture of sizes and styles that one could be forgiven for thinking that some might have been imported from other churches. Four benches on the south side of the nave have 17th-century ends.

Beneath the chancel arch stands the dado (or base) of the 15th-century **rood screen**. Its original traceried panels have now lost all traces of their former paintings, but exquisite little carvings survive in the traceried panels near the top, including two birds, one of which is a pelican, pecking at her breast to feed her young with her own blood – a symbol of Christ's sacrifice on the cross. The gate is a 17th-century addition but beneath it the original base still continues unbroken across the entrance – an unusual feature; it is 10½ inches (27 cm) deep. Above this dado, openwork traceried panels

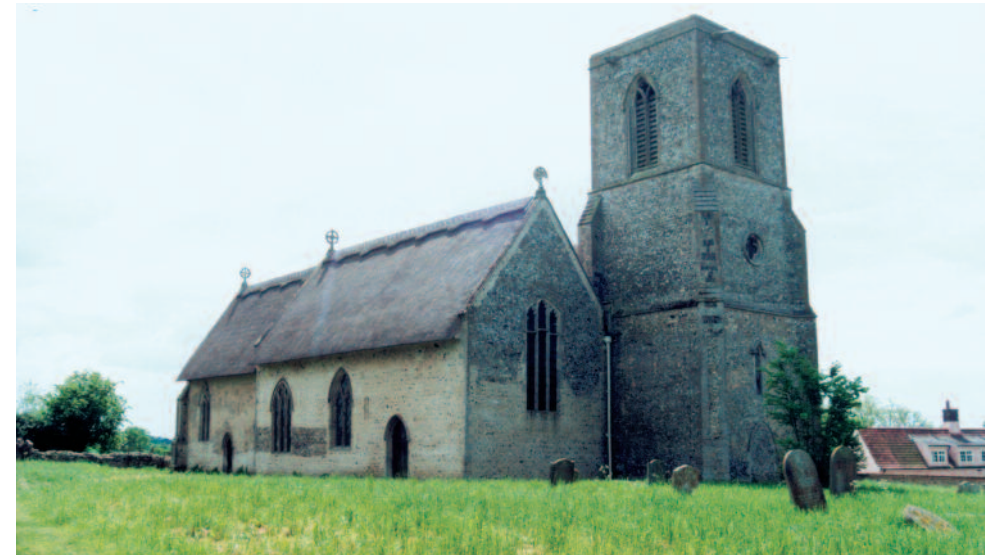
Exterior from the east, showing the splendid tracery in the east windows

embellished with cusping, forming lobes, as in the south-east aisle window. More intricate tracery then developed, as in the north and south chancel windows, with their elegant curvilinear tracery and the fine three-light east window. The largest window is the five-light east window of the aisle, which has net-like reticulated tracery of c. 1330, a design also used in the double north nave window. The west window of the nave was added some 150 years later, in the Perpendicular style.

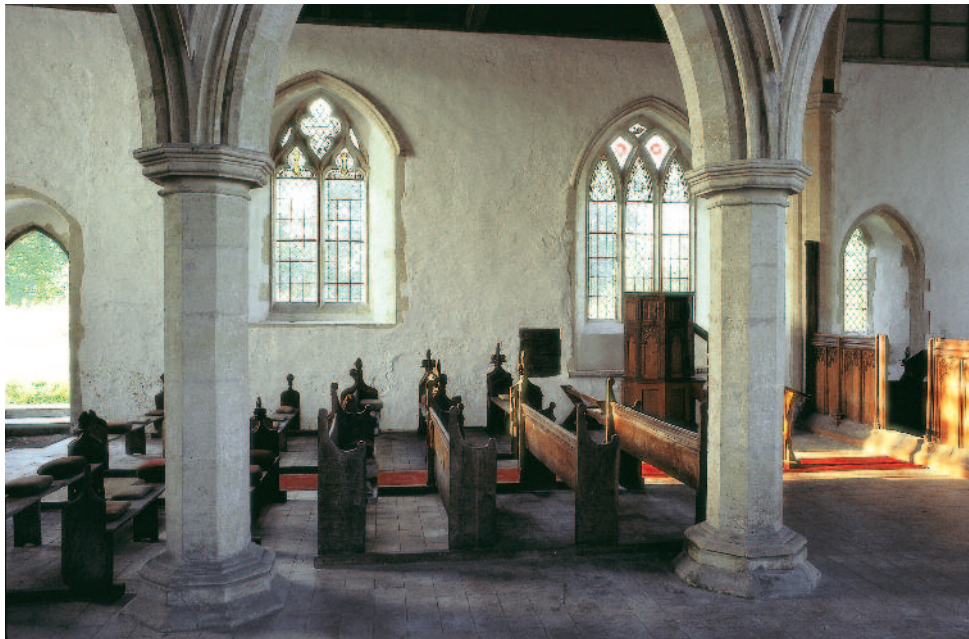
Left: Interior looking south-east to the roof-loft stairs, south aisle niches and the array of benches (Christopher Dalton)

The splendid **east window** of the aisle has an internal hood mould studded with flowers and foliage. It is flanked by two sumptuous **niches**, built to contain statues of the saints who were honoured at the altar here. Although now but fragments of their former glory, what remains is of great beauty. They still bear traces of their mediaeval colouring, are flanked with pinnacles and are quite different from each other in design. The southern niche has a crocketed triangular top above its cinquefoil ogee-shaped arch. The canopy inside is vaulted and has a central boss. It appears that there were two creatures at the base and the sides are covered with floral designs. Its northern counterpart has two-light traceried panels at the sides, which terminate in crocketed gables. The central canopy, which was also vaulted, is now lost.

would have risen to the rood loft, along which it was possible to walk. Access to this was gained by means of the **rood-loft staircase**, which still remains to the south of the chancel arch, its upper entrance opening onto the loft. The **sockets** in the stonework of the arch above the capitals show where the rood beam fitted, upon which were fixed the great Rood (Christ crucified and flanked by his mother and St John). Maybe the notches nearer to the summit of the arch had something to do with the fixing of the rood, or possibly with a painted tympanum fitting into the top of the arch.

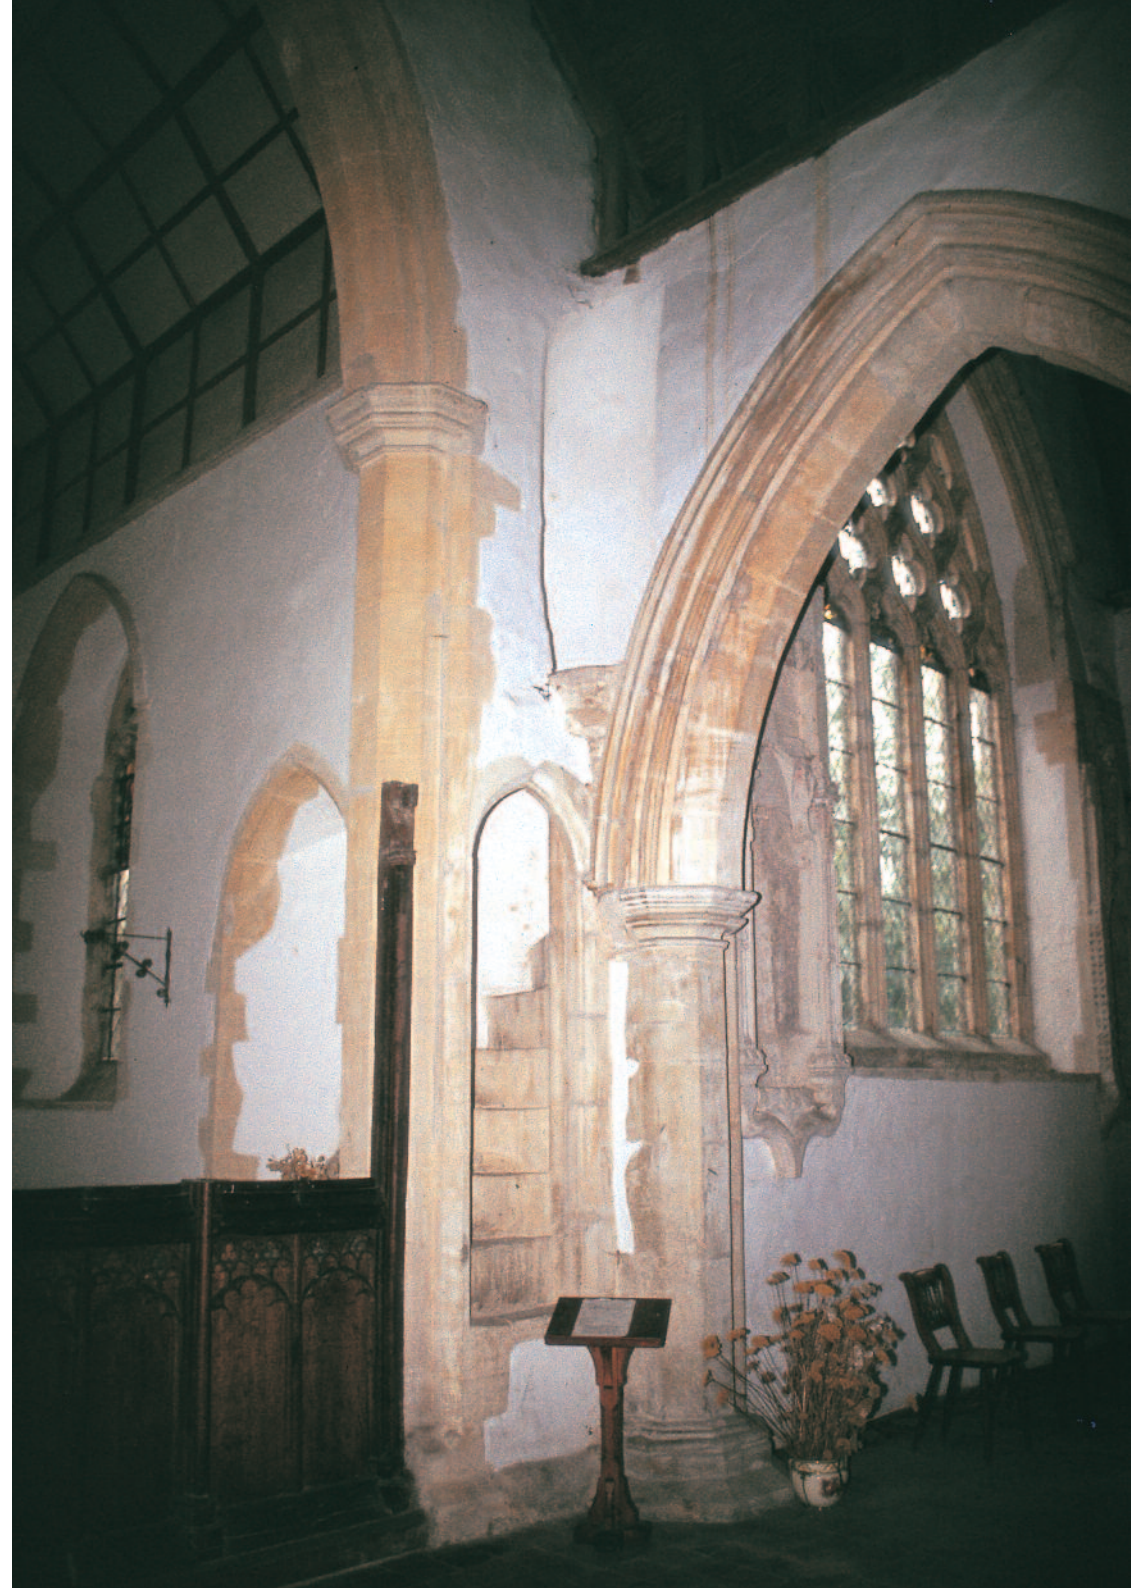
Right: The rood-loft staircase in the south-eastern corner of the nave
